# Manhole Inspection Summary

Manhole # S47GG\_020MH

Record Plat: **47GG** Node: **020** Status: **Found**

**Location** Address: **Preston**

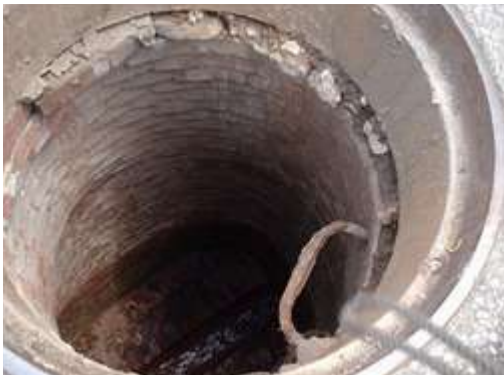
Defect 2

Condition: ☐ Sound ☐ Cracked ☐ Root Intrusion ☒ **Loose Brick** ☐ Deteriorated

Infiltration: ☐ None ☒ **Joint** ☐ Cracks ☒ **Mortar** ☐ Roots ☐ Wall

loose bricks

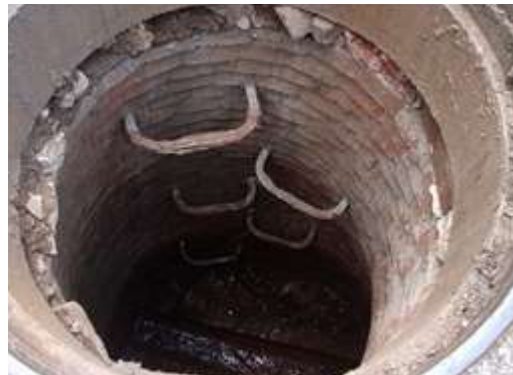
Defect 1

**Frame** Offset: **2** (in.) Condition: ☐ Sound ☐ Cracked ☒ **Leaks**

frame leaks

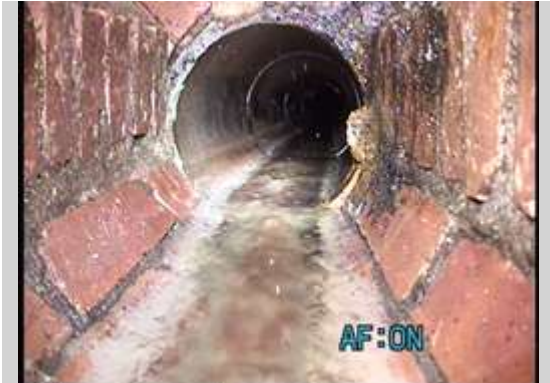
12 O'Clock Outflow

8 in. Circular Gravity Sewer  
Pipe Out @ 12 O'Clock

Pipe Height: **8.4** (in.) Rod and Bar (Angled)  
Pipe Material: **Clay** ☐ Pipe Lined  
Invert Depth: **9.25** (ft.) Flow Characteristics: **Fast**  
Deposits: ☒ None ☐ Mud ☐ Sludge ☐ Debris ☐ Grease  
Silt Depth: (in.) Deposits Extent:  
Infiltration: **None** Pipe Seal Cond: **Sound**

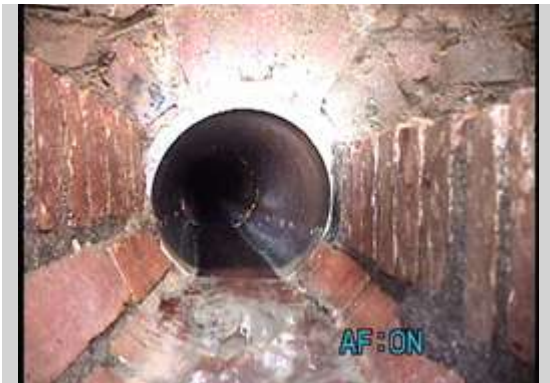
6 O'Clock Inflow

8 in. Circular Gravity Sewer  
Pipe In @ 6 O'Clock

Pipe Height: **8.4** (in.) Rod and Bar (Angled)  
Pipe Material: **Clay** ☐ Pipe Lined  
Invert Depth: **9.35** (ft.) Flow Characteristics: **Fast**  
Deposits: ☒ None ☐ Mud ☐ Sludge ☐ Debris ☐ Grease  
Silt Depth: (in.) Deposits Extent:  
Infiltration: **None** Pipe Seal Cond: **Sound**
